2012 LONG-TERM MONITORING DATA SUMMARY REPORT ST. LAWRENCE RIVER REMEDIATION PROJECT

Alcoa Inc.
Massena, New York

Anchor QEA, LLC
ARCADIS

February 2013

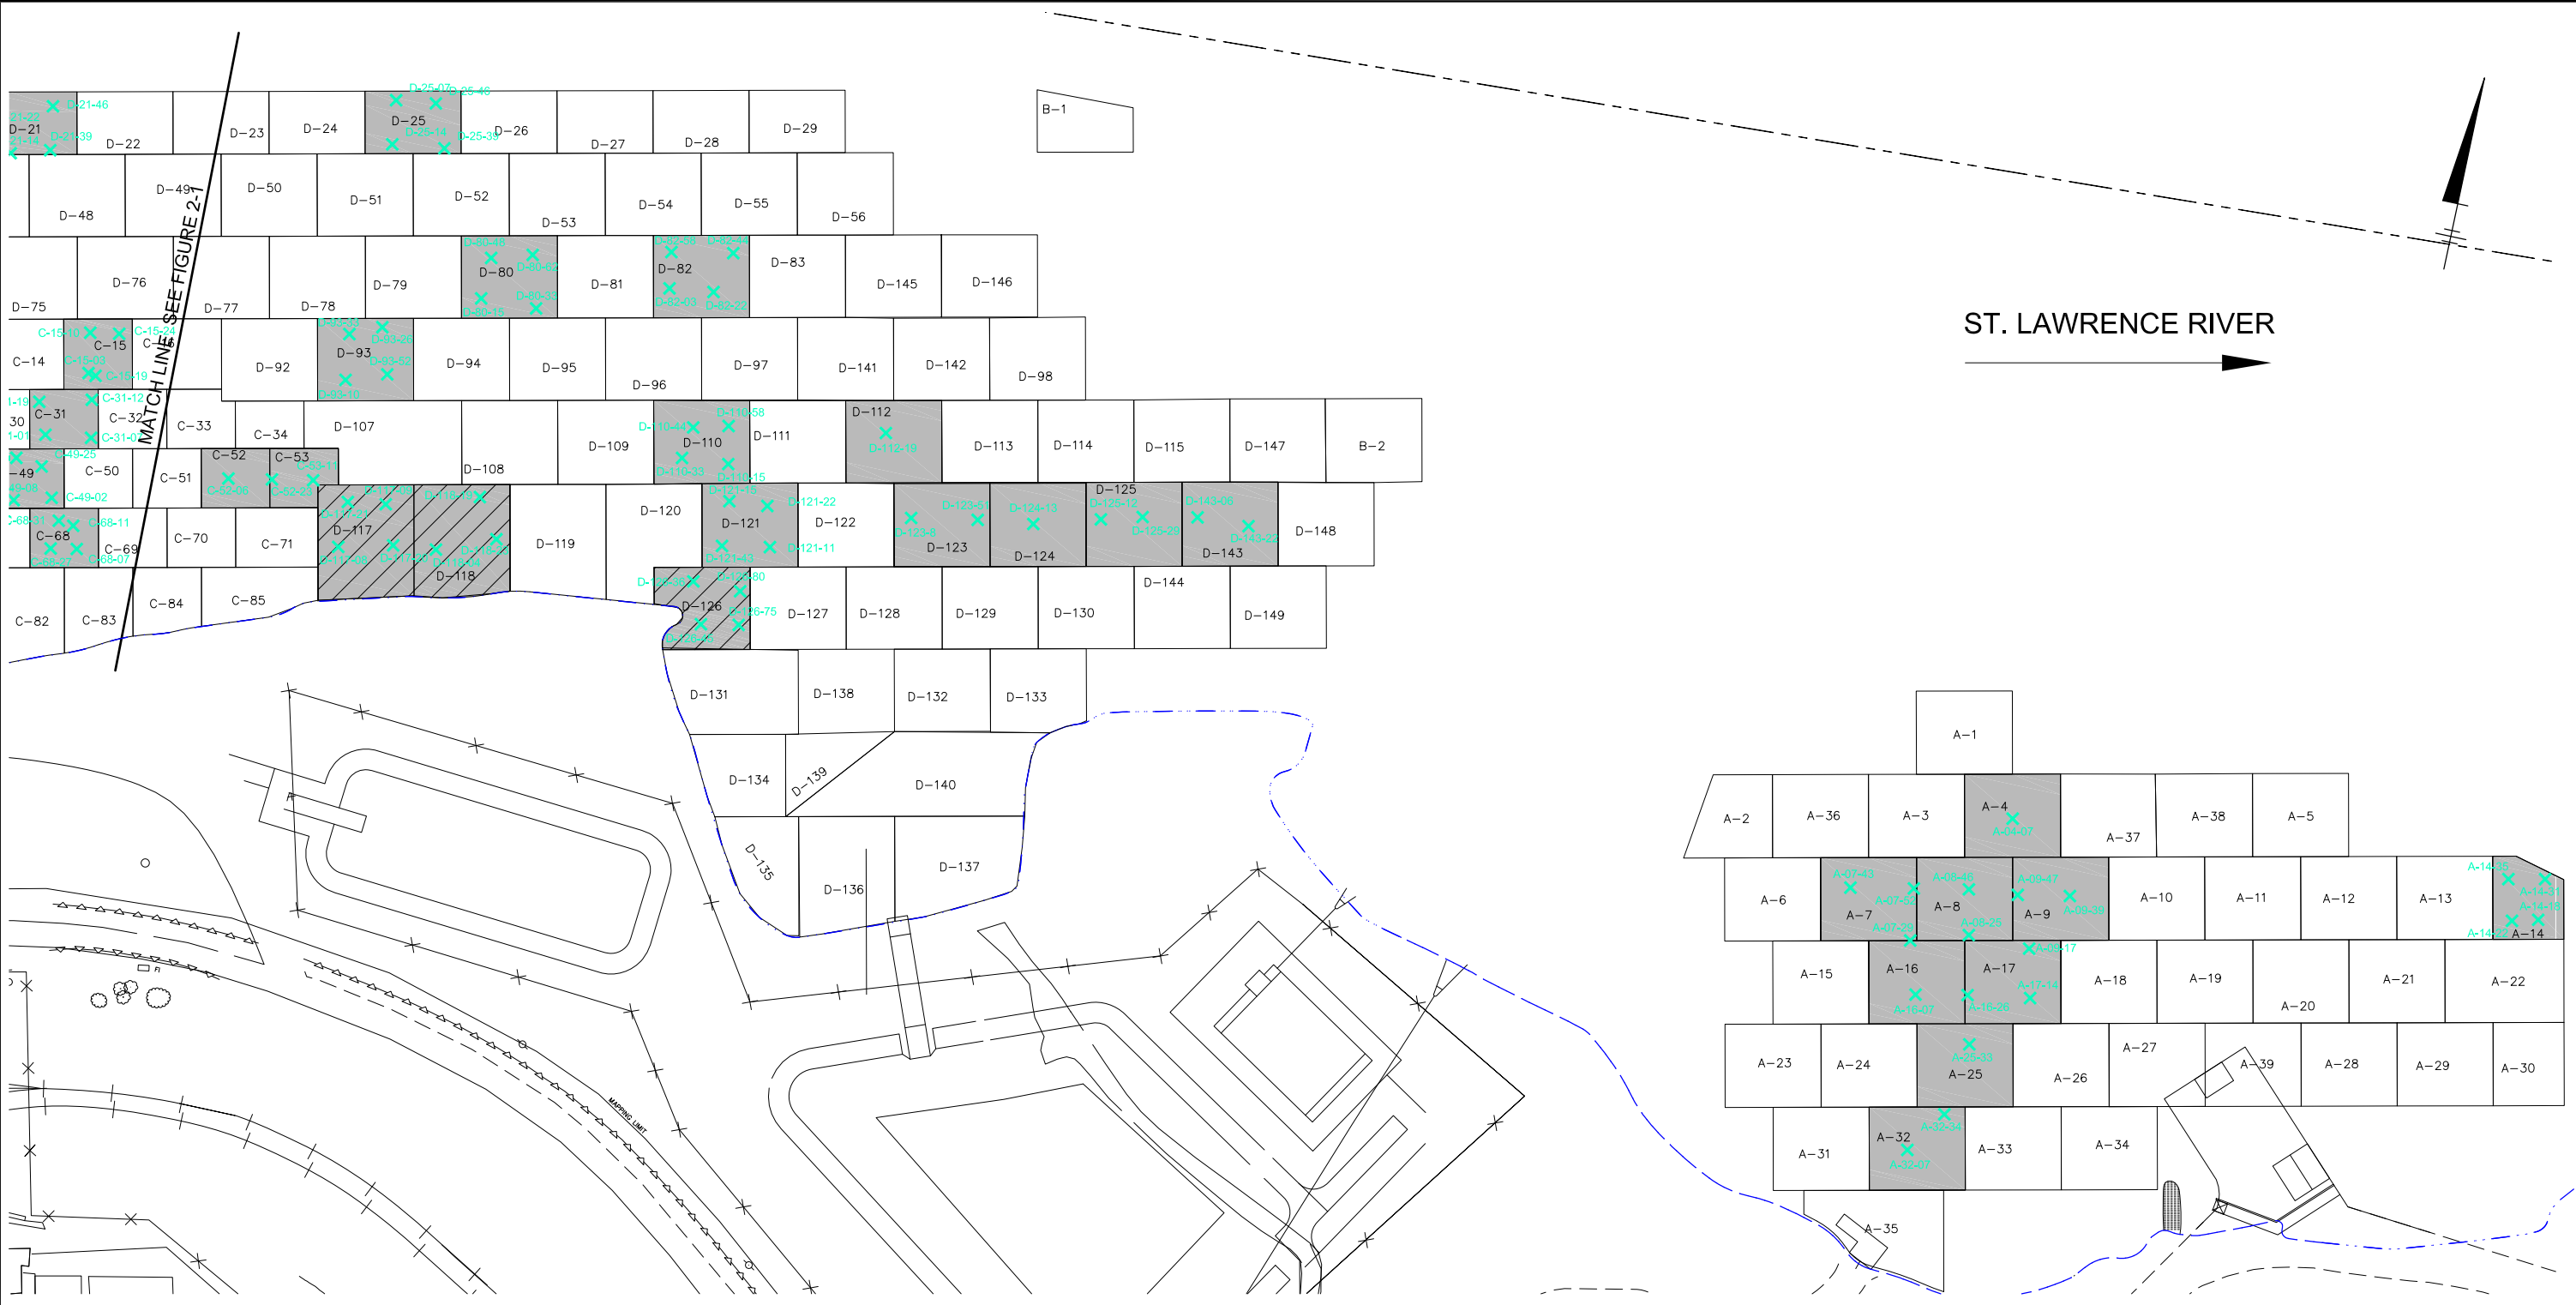
FIGURE
2-2

**PHYSICAL CONDITION
CAP MONITORING LOCATION -
DOWNSTREAM PORTION**

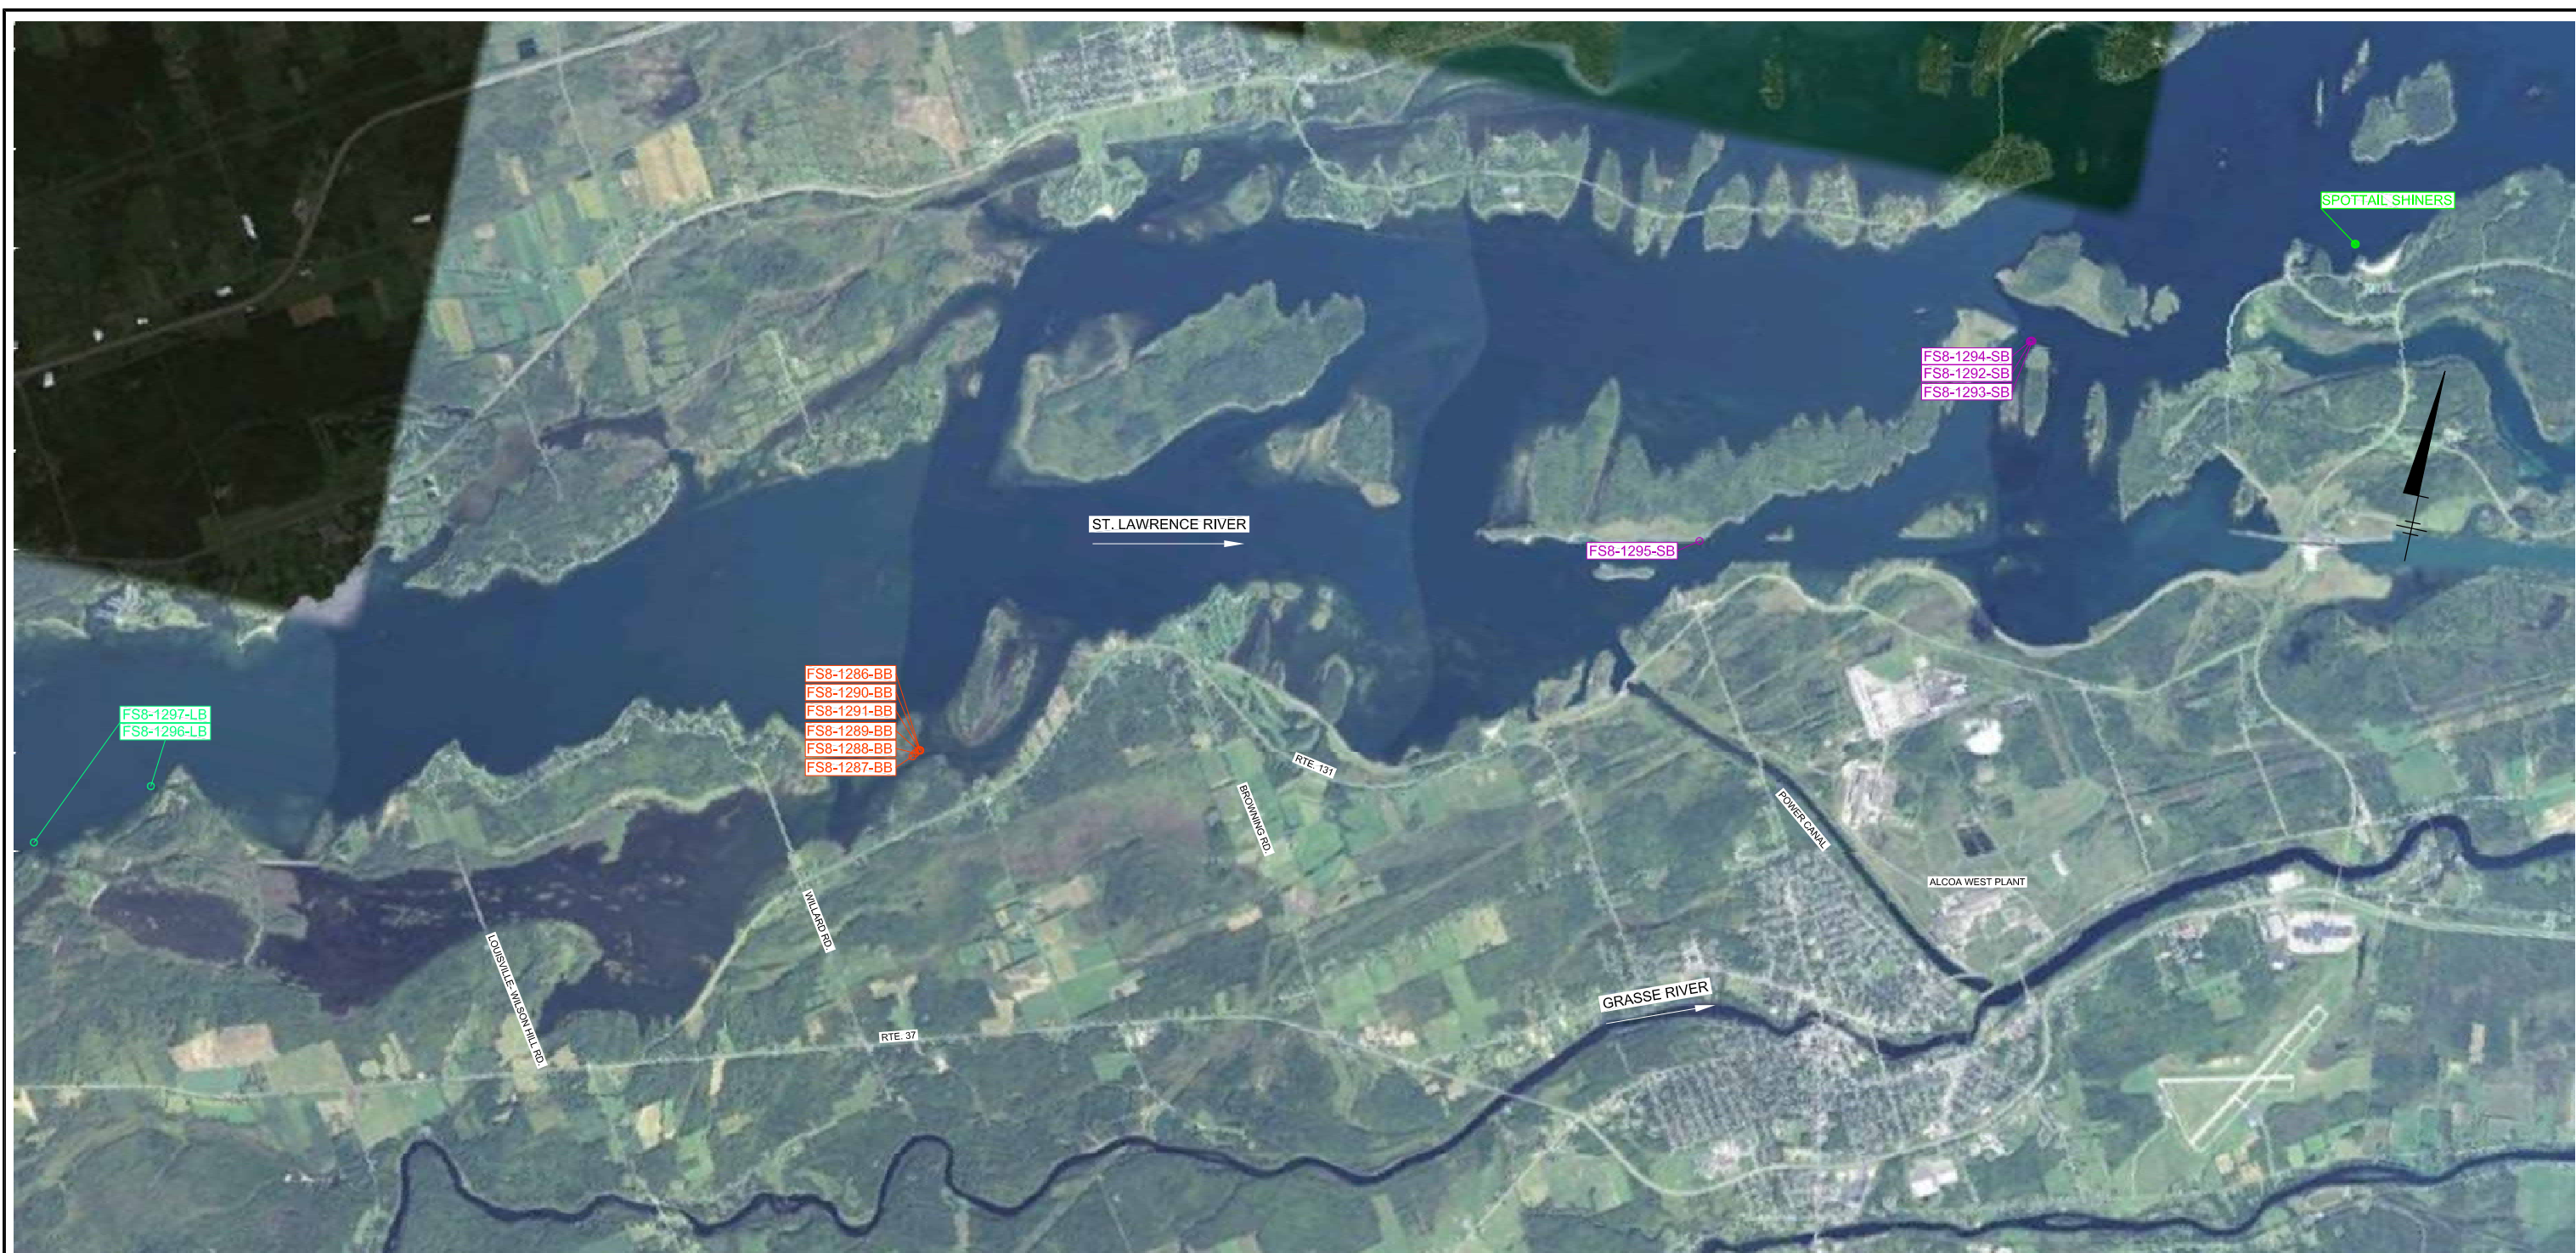
FIGURE
2-3

In accordance with the LTMP, YOY spottail shiners (*Notropis hudsonius*) were targeted from the Site and from a background location upstream of the Robert Moses-Saunders Power Dam in the vicinity of Barnhart Island. Sampling locations are shown on Figures 2-3 and 2-4.

Six individual smallmouth bass and six individual brown bullhead samples were collected from the Site remediation area and the area downstream of the Site. Four individual smallmouth bass, two individual largemouth bass (*Micropterus salmoides*), and six individual brown bullhead samples were collected from the upstream background area (Figure 2-3). In total, 18 adult bass and 18 adult bullhead samples were collected. Largemouth bass were collected at the upstream background area as a substitute species due to limited availability of smallmouth bass at this sampling location. In addition, the upstream background area was expanded further upstream of Barnhart Island in order to fill the required sample size (Figure 2-3).

FISH SAMPLE COLLECTION LOCATIONS -
BACKGROUND

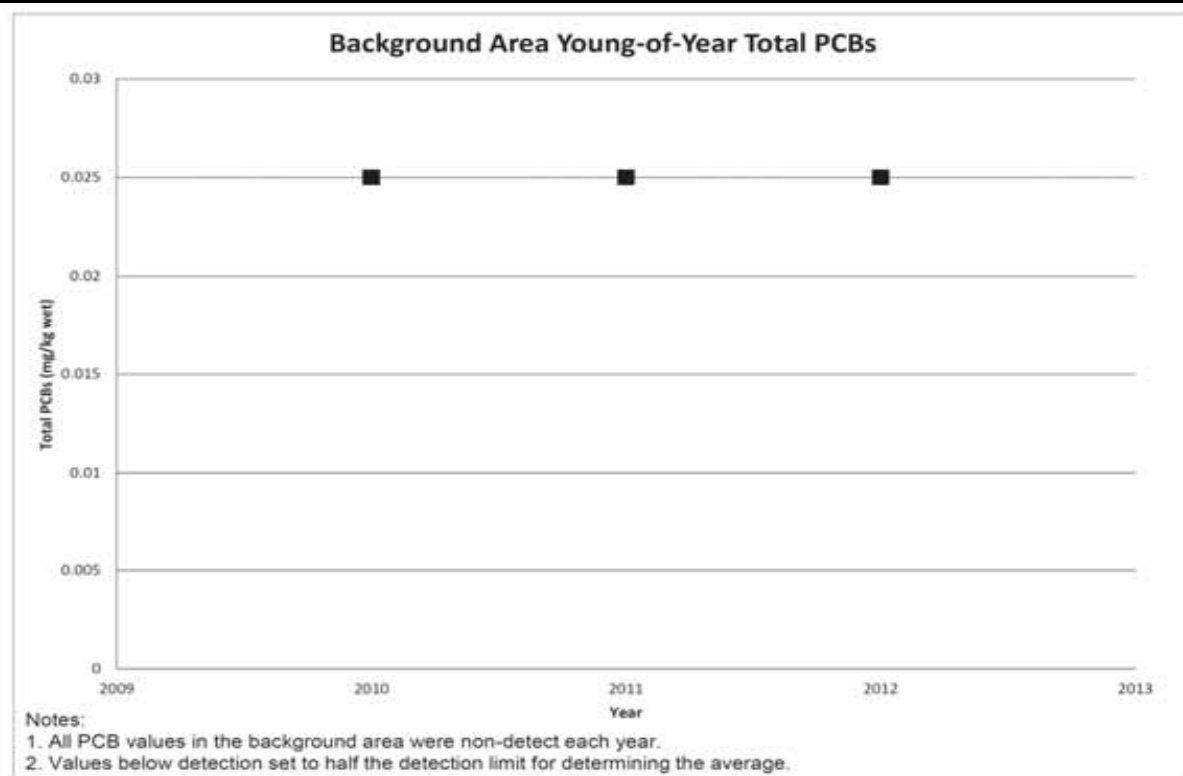
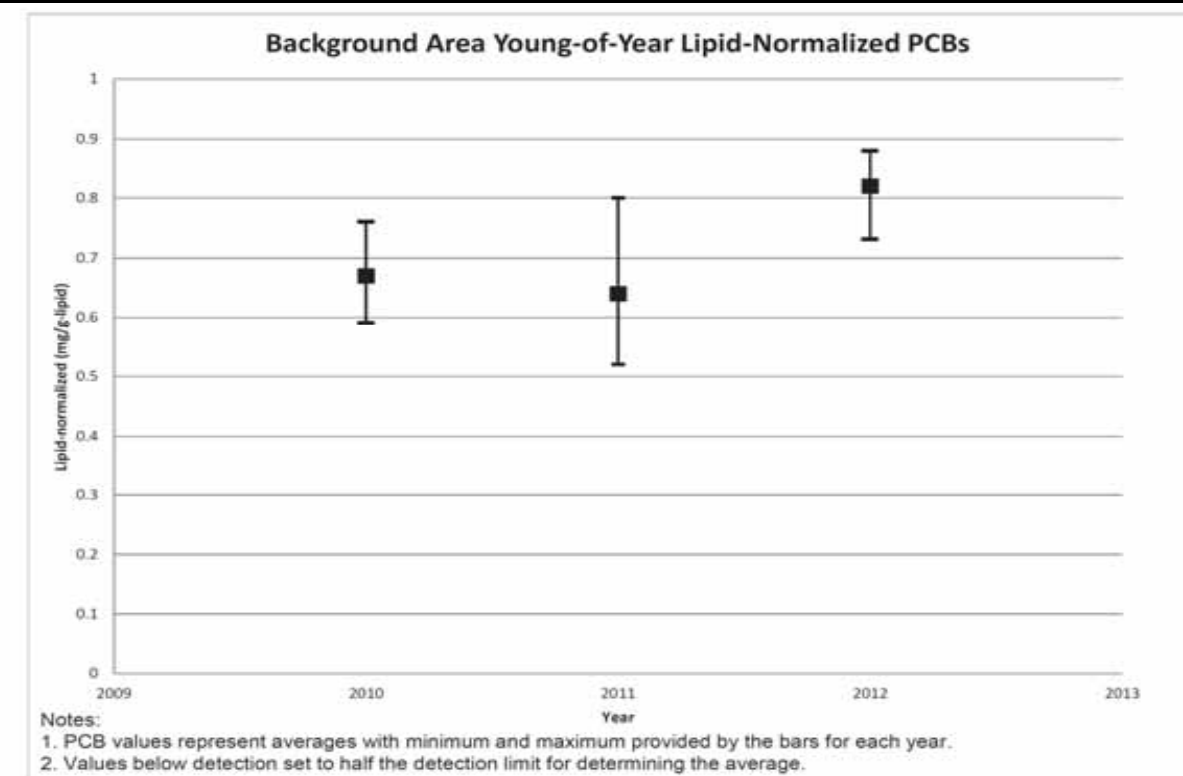
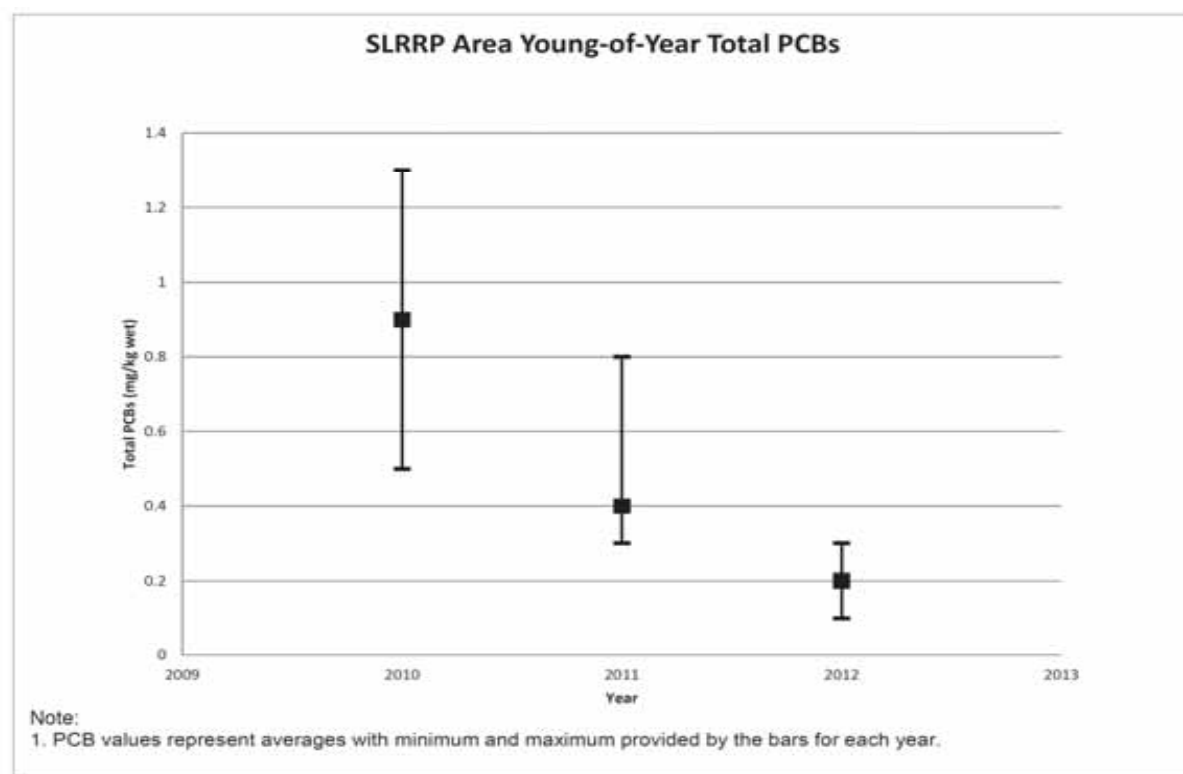
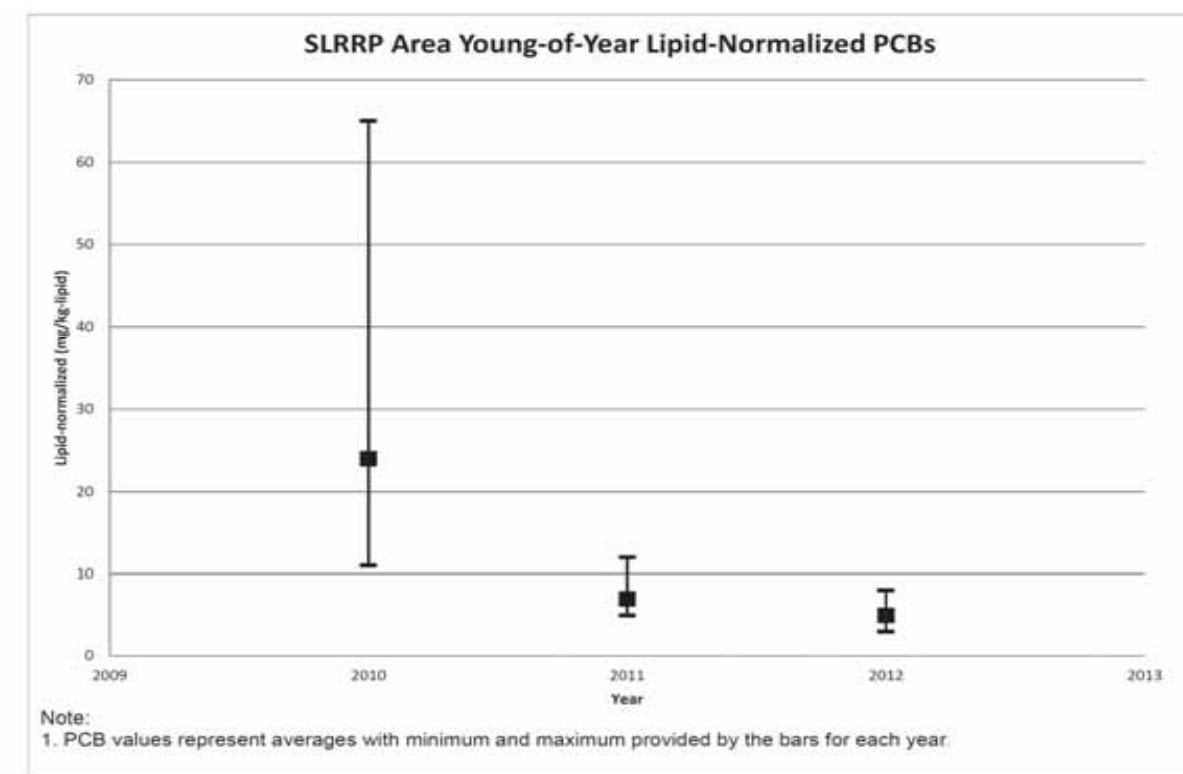
Young-of-Year PCB Results

PCB concentrations in whole-body YOY spottail shiner samples at the Site in 2012 were approximately half of the concentrations observed in 2011, and approximately a quarter of the concentrations in 2010 (Figure 2-5). Mean wet weight PCB concentrations in 2010 at the Site were 0.92 mg/kg (range of 0.49 to 1.3 mg/kg) compared to 0.41 mg/kg (range of 0.28 to 0.76 mg/kg) in 2011 and 0.23 mg/kg (range of 0.12 to 0.33 mg/kg) in 2012. Lipid-normalized PCB results showed similar declines, with mean concentrations in 2010 at the Site of 24 mg/kg-lipid (range of 11 to 65 mg/kg-lipid) compared to 7.2 mg/kg-lipid in 2011 (range of 4.8 to 12 mg/kg-lipid) and 4.8 mg/kg-lipid (range of 2.8 to 8.3 mg/kg-lipid). PCBs were non-detect in the upstream background area in all sampling years (2010 to 2012).
